**INFLUENCE OF SMALL VESSEL OPERATION AND
PROPULSION SYSTEM ON LOGGERHEAD SEA TURTLE
INJURIES**

In Partial Fulfillment
of the Requirements for the Degree
Master of Science in the
School of Civil and Environmental Engineering

Georgia Institute of Technology
May 2010

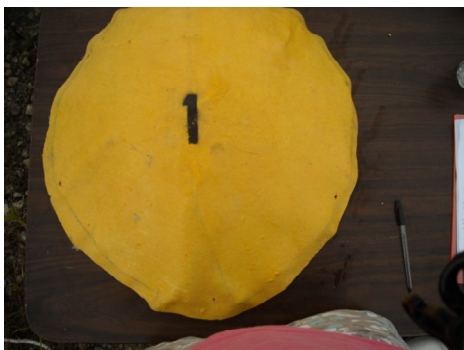
No visible damage.

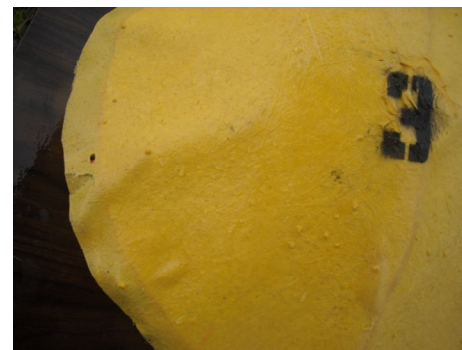
Small notch at position 4.

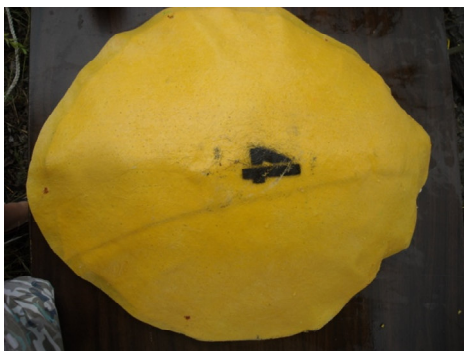
Minor scrape on top on top of shell.

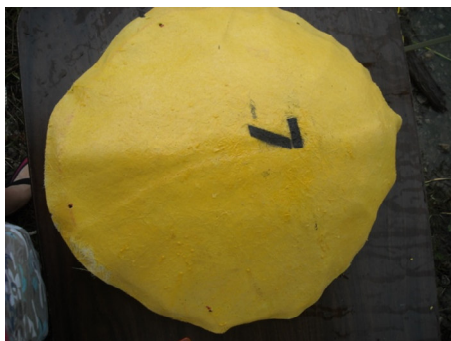
No visible damage.

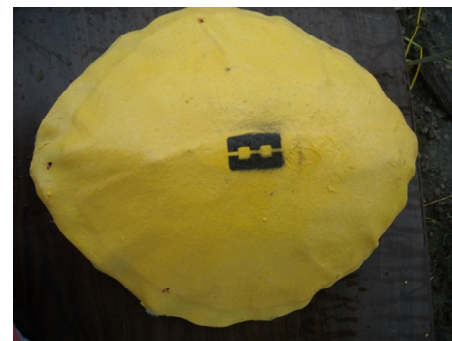
No visible damage.

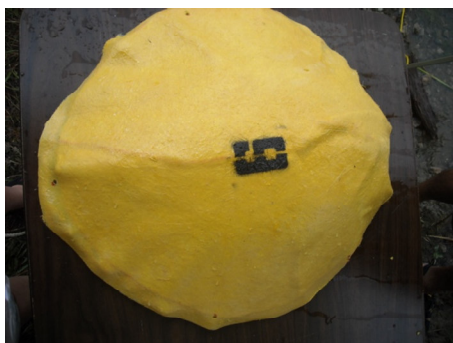
No visible damage.

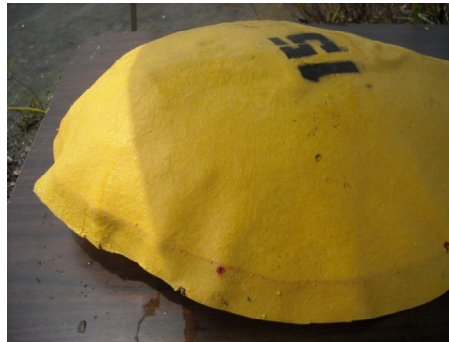
Small cut at position 1-4.

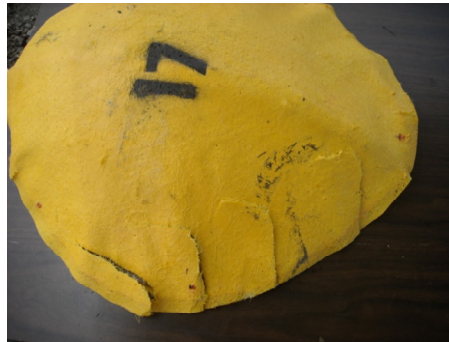
Prop cuts along the edge at position 3-4.

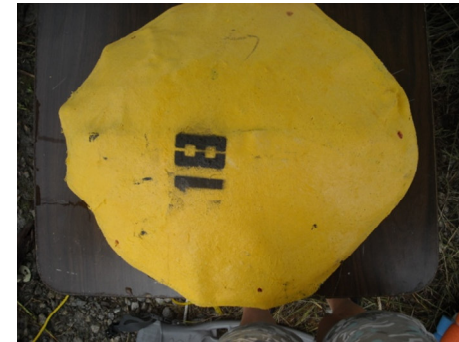
No visible damage.

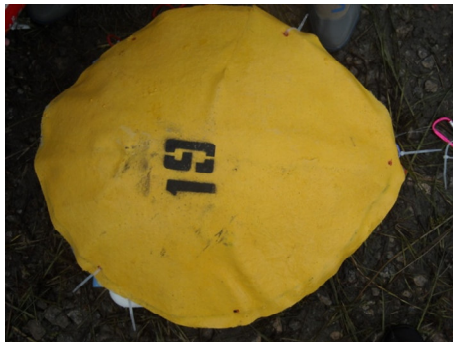
No visible damage.

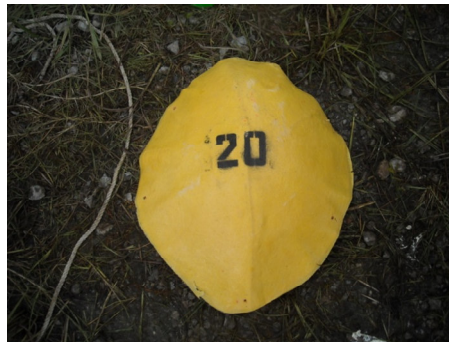
5 tests run, no contact with shell.

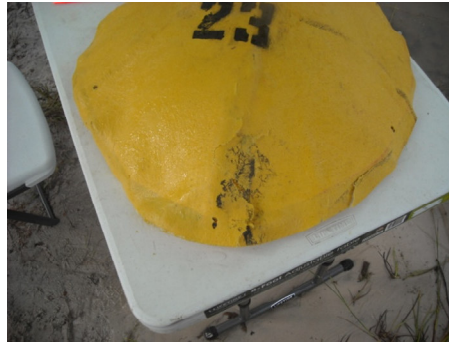
Blunt force wound at position 3, possible prop cut at position 2-3.

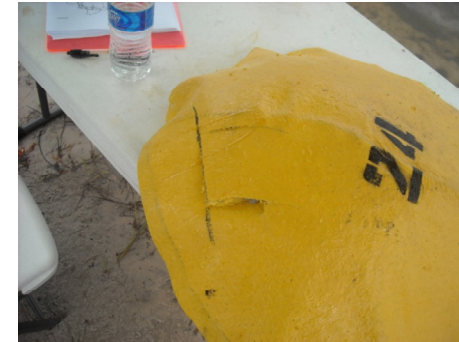
Skeg mark and prop cuts from position 1 to position 4.

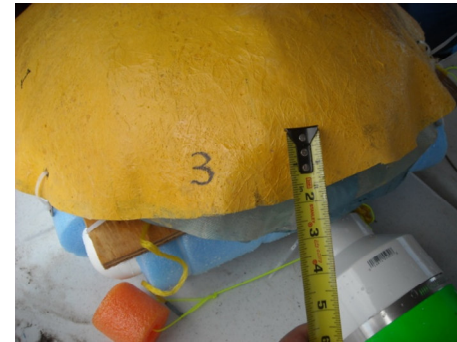
Mark with not tear at position 1.

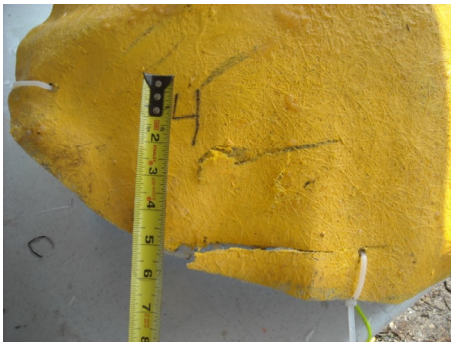
Prop cuts on edge at position 2-3.

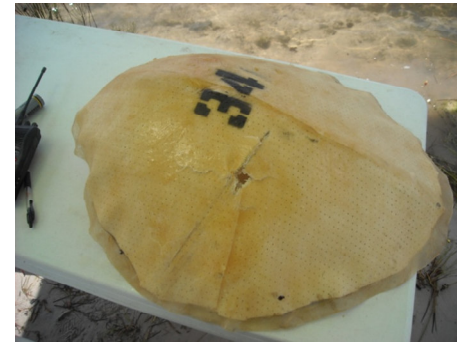
Blunt puncture, top of shell, left side.

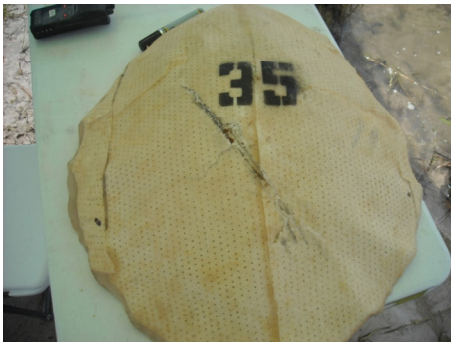
Blunt puncture top of shell, middle. Mark across shell from 2-3 to 4-1.

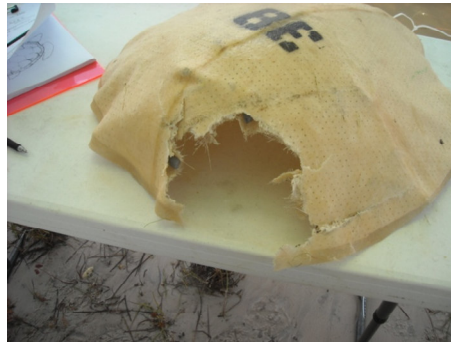
Blunt strike, large tear out at position 1-4.

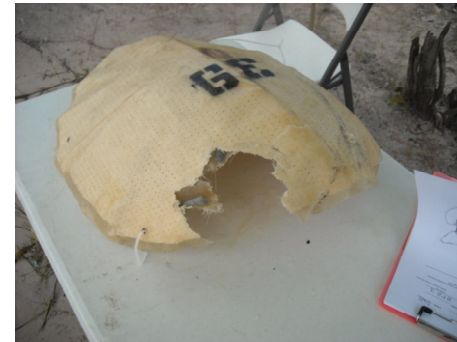
Blunt strike, large tear out at position 1-2.

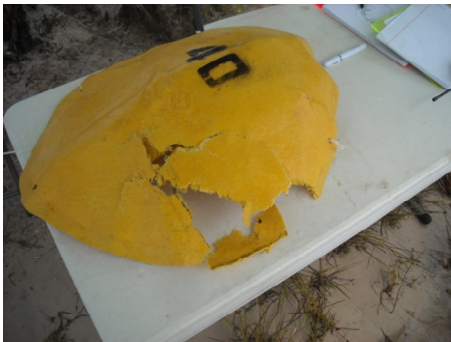
Blunt strike, large tear out at position 2.

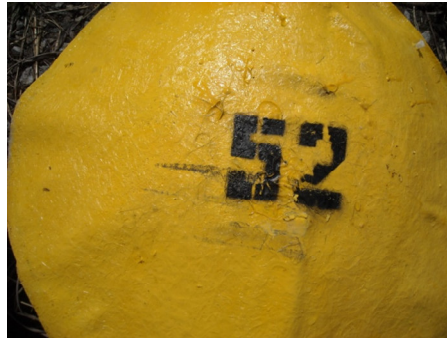
Small scrapes, 4 grating marks on top.

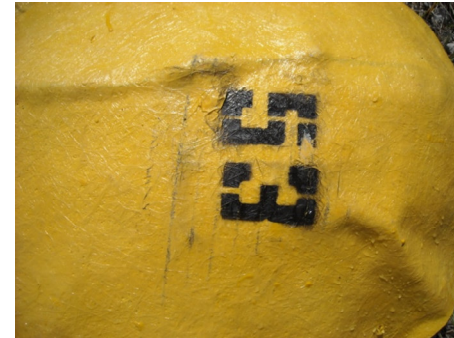
10 intake grating marks on top.

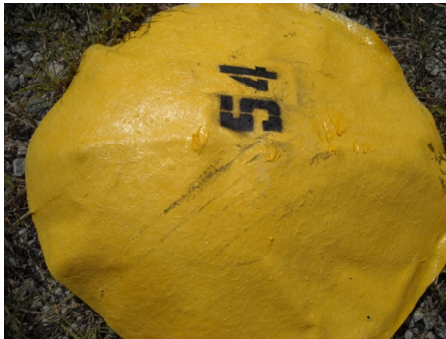
6 intake grating marks on top, small scrape.

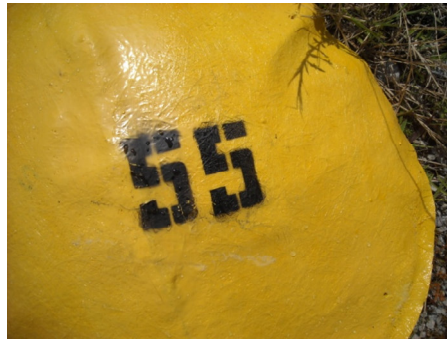
3 grate marks, no slices or cuts.

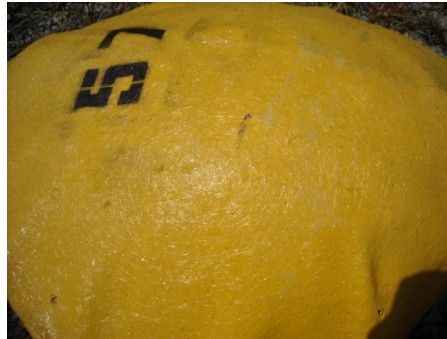
Light scrapes on top of the shell.

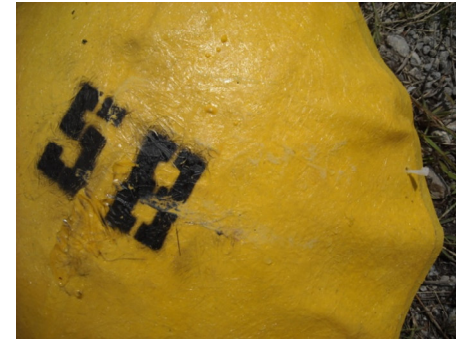
Light scrapes on surface, no cuts.

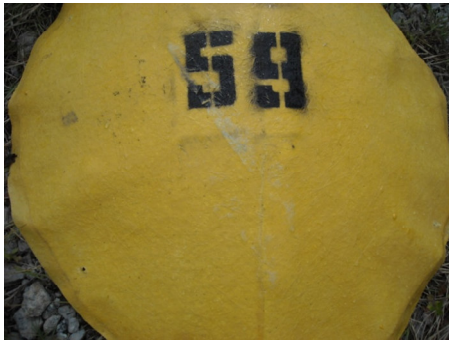
Glancing blow at impact, 2 light scrapes, no cuts.

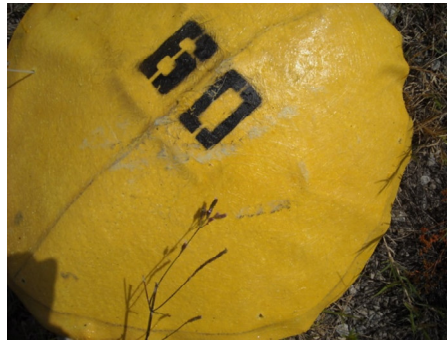
Light scrapes, no cuts or gouges.
